GORGAS HOSPITAL, KITCHEN AND MESS BUILDING (Gorgas Hospital, Building 238)
West of Administration and Clinics Building
Balboa Heights Vicinity
Former Panama Canal Zone
Republic of Panama

HABS No. CZ-11-B

GORGAS HOSPITAL, KITCHEN AND MESS BUILDING (Gorgas Hospital, Building 238)

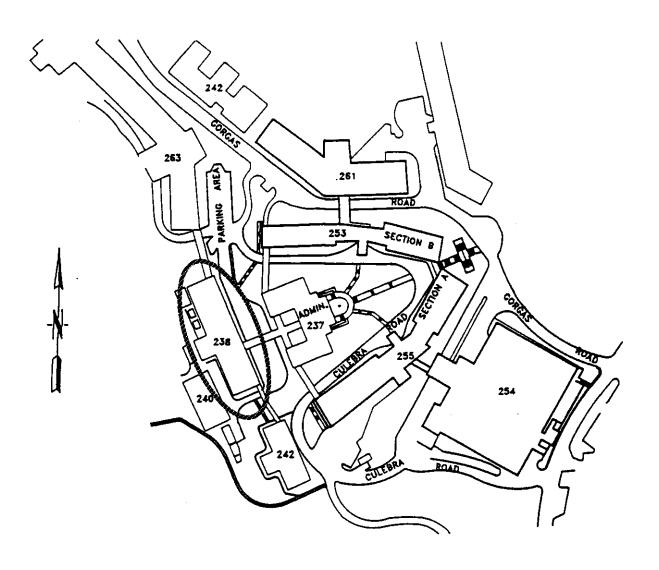
Figure 1 Map, 1996 (original located at Real Property Office, Corozal).

Mapmaker unknown.
